**Federal Aviation
Administration**

ADVISORY CIRCULAR 43-16A

AVIATION MAINTENANCE ALERTS

ALERT
NUMBER
302

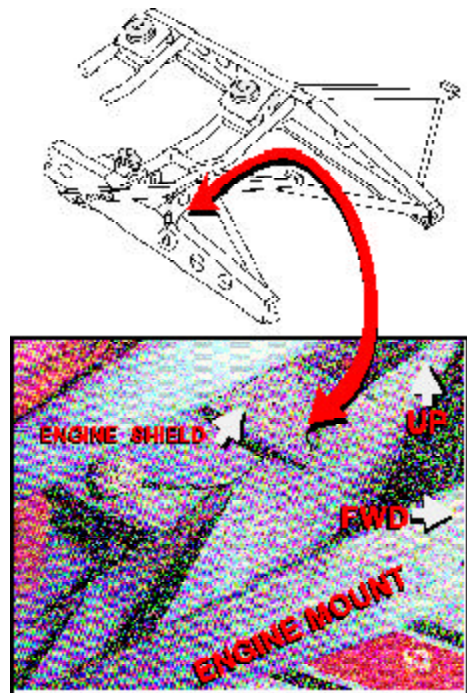
Beech; Model 58P; Baron; Damaged Engine Mount Truss; ATA 7120

During a phase inspection, the technician noticed that the exhaust heat shield, which is forward of the turbocompressor, had chafed through the engine-mount truss (P/N 102-910026-131).

The technician stated the chafed area was approximately 3/16 inches by 5/16 inches. He stated the damage occurred when the heat shield mount broke and contacted the truss. (Refer to the illustration.)

The submitter stated that this is a common problem. He stated that Beech has an approved repair procedure, which addresses this problem.

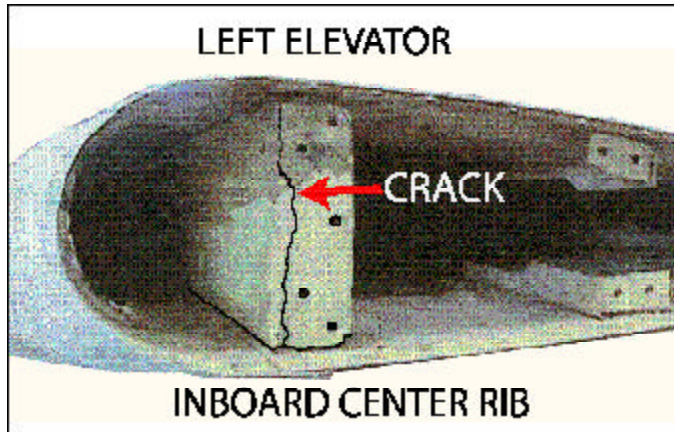
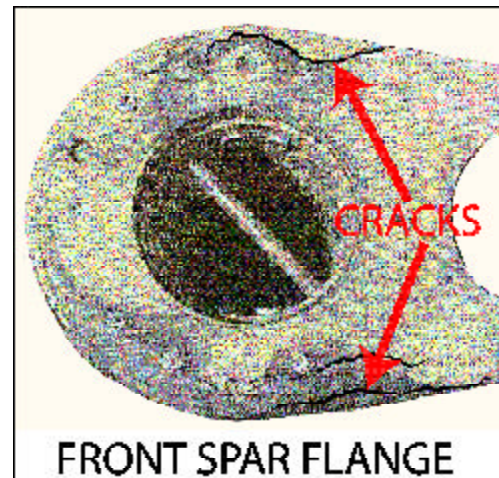
Beech; Model E-90; King Air; Elevator Structure Failure; ATA 5521

A report in the FAA Service Difficulty Reporting Program data base stated that a technician discovered cracks at the inboard rib (P/N 50-610000-355) of the left elevator. Cracks were also discovered at the front spar flange (P/N 50-610000-387). (Refer to the illustrations.)

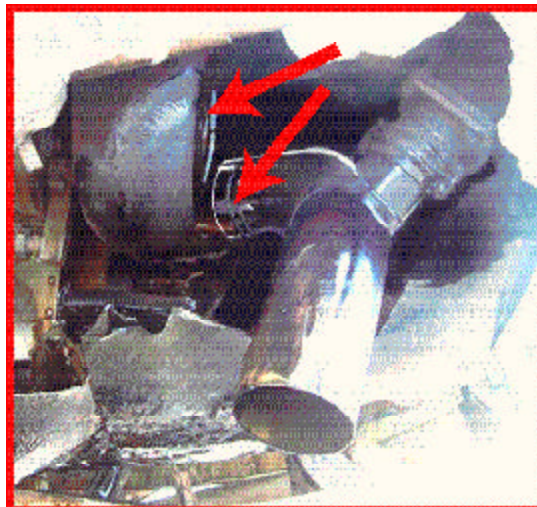
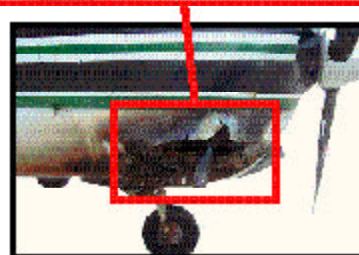
Cessna; Model T210; Turbocharger Tailpipe Clamp; ATA 8120

Recently, a Cessna T210N Turbo Centurion airplane made an emergency landing after descent from a cruise altitude of above 10,000 feet as a result of the pilot initially observing electric and hydraulic system malfunctions and then smelling smoke.

Inspection of the airplane on the ground revealed that the engine exhaust tailpipe had separated from the turbocharger. The V-Band clamp used to secure the turbocharger to the exhaust tailpipe was still attached to the turbocharger. The self-locking nut that is torqued to secure the V-Band clamp had loosened enough to allow the tailpipe to separate from the turbocharger. It was determined that the self-locking nut was not the correct type.

This condition has been suspected when other Cessna turbocharger tailpipe separations have occurred. There are Airworthiness Directives on some Cessna airplane models to insure proper attachment of the turbocharger to the tailpipe but not on the Cessna T210 Series airplanes.

The purpose of this Alert is to emphasize the need to use the approved type of hardware, especially on exhaust systems. The pictures are included to further convey this message.

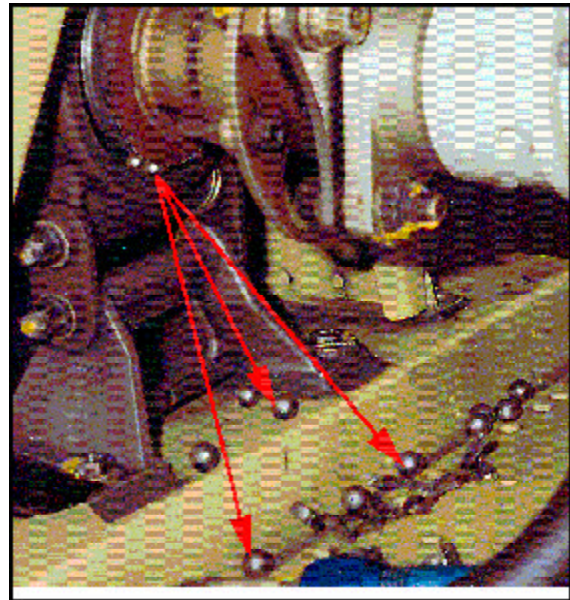
Bell; Model 407; Oil Cooler Blower Bearing Failure; ATA 6510

During a routine maintenance inspection, the technician discovered the rear oil cooler fan shaft bearing (P/N 407-340-339-101) had suffered complete failure.

The technician stated the bearing is part of the aircraft tail rotor drive system. He found bearing balls and pieces of the bearing cage on the aircraft oil cooler deck area. One ball from the bearing was lodged in the oil cooler impeller. He discovered that there was very little grease in the bearing pieces and the remaining races. (Refer to the illustration.)

He recommended increasing the intervals between lubricating this area. He also recommended replacing the bearing with a bearing that will withstand the heat that is generated in this area and still retain sufficient lubrication.
